# **Intel® Mobile Celeron™ Processor Specification Update**

Release Date: June 1999

Order Number: 244444-005

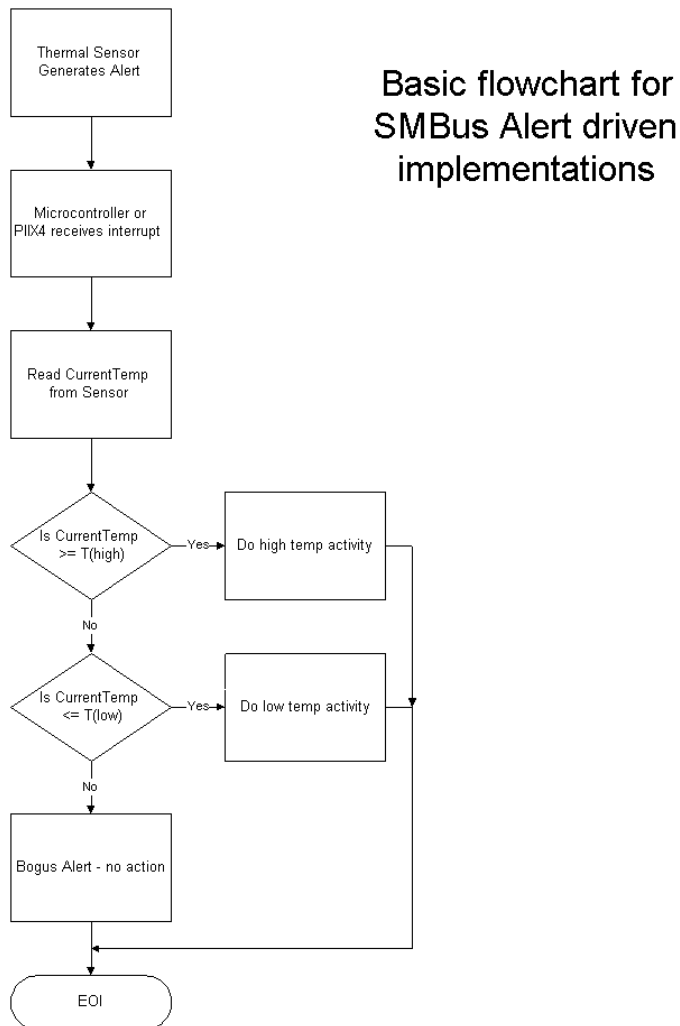
Figure 2. Workaround Flowchart: SMBALERT#-Driven System

Under the conditions described below, the thermal sensor incorrectly generates the SMBALERT# interrupt. *All* of the following conditions must be met to trigger a false interrupt:

1. Before servicing an interrupt from the thermal sensor, read and compare the processor thermal reading with the threshold limits ( $T_{HIGH}$  or  $T_{LOW}$ ). Figures 2 and 3 provide basic flowcharts for the implementation of this workaround in an interrupt driven system.
2. If the firmware implemented polls the Status Register only, then before taking any action, re-read the temperature register and do a comparison with the alarm threshold limits ( $T_{HIGH}$  or  $T_{LOW}$ ) to determine if the value is actually still within the temperature window.
3. Use a temperature polling scheme to monitor the processor temperature.
